Net Zero  
Teesside

# Net Zero Teesside – Environmental Statement

### Appendix 10A: Preliminary Sources Study Report

## Annex F – Site Walkover

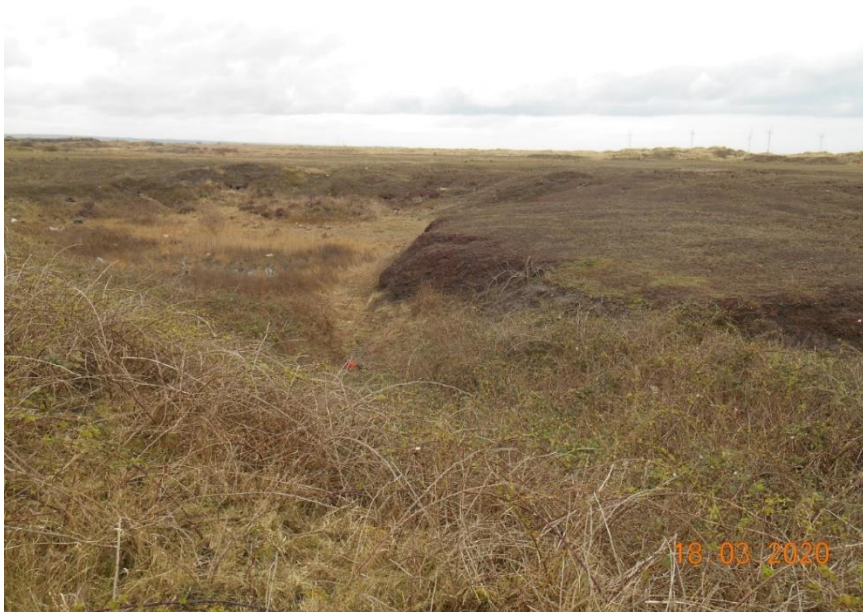
Plates 1, 2 and 3 show areas of steel slag waste, most likely placed during the operation of the Redcar Iron and Steelworks (present between 1929 and 1973) tipped immediately north of the Site across the proposed Onshore CO<sub>2</sub> corridor. These areas of slag extend north to Blown Sands deposits of the natural beach sand and dune habitats, although these areas are also most likely underlain with man-made materials placed between 1856 and 1894, associated with early land reclamation and construction of defences from the North Sea.

**Plate 1 – View looking north east showing areas of steel blast furnace waste slag with the existing offshore windfarm visible in the distance.**

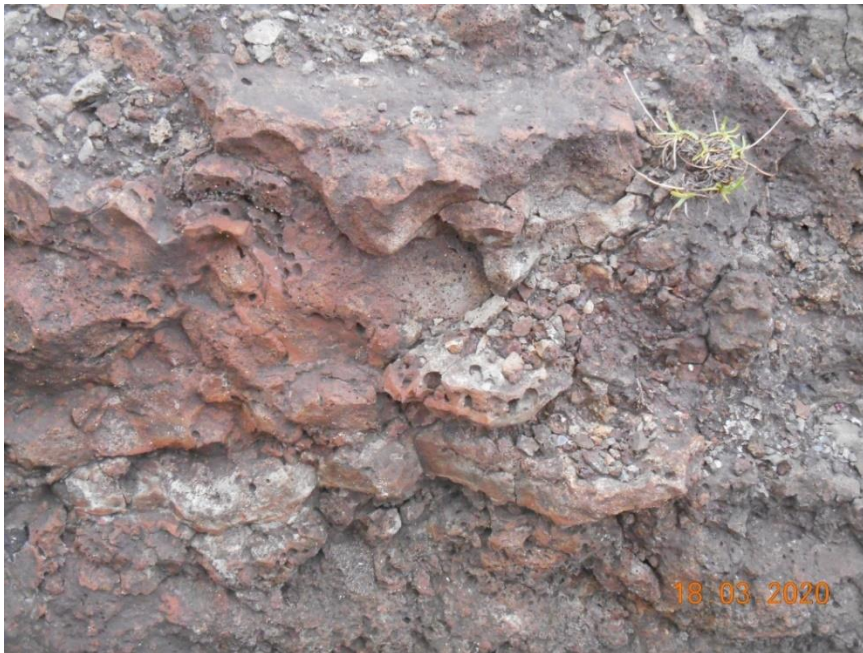
**Plate 2 -Typical composition of the fused blast furnace slag.**

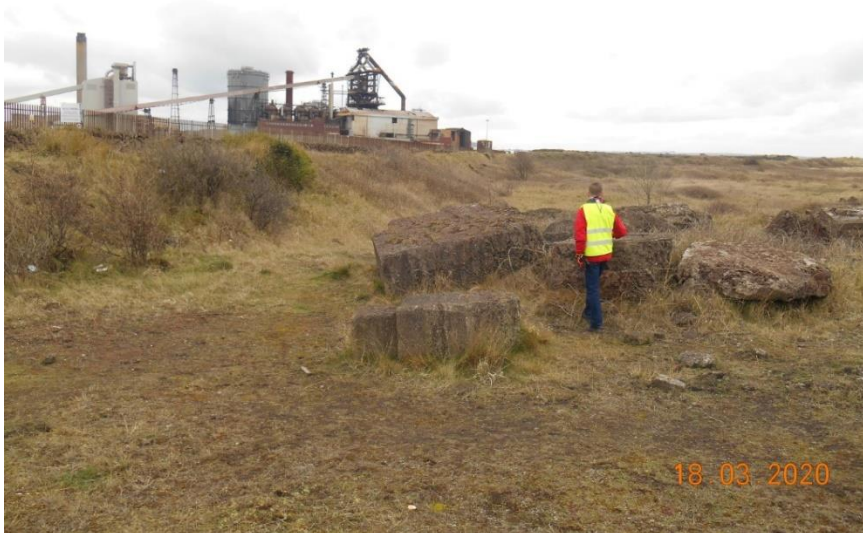
It was noted that there are localised areas of spoil comprising large discarded fused slag and old concrete foundations from previous industrial development across this area, see Plate 3.

**Plate 3 – View looking south west showing large concrete blocks thought to be foundations from previous land use within the Main Teesworks Site shown on the foreground, and the former blast furnace on the right-hand side of the photograph which is outside and adjacent to the east boundary of the site.**

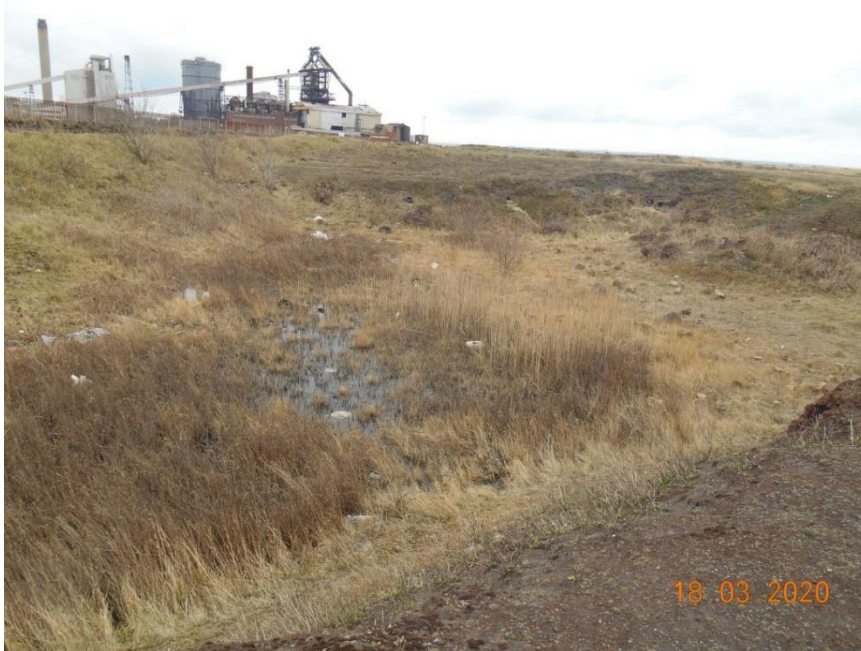
Sites were generally dry or marshy, see Plate 4. These ponded areas are shown as different sizes over different dates of OS mapping, suggesting they are influenced by seasonal rainfall.

**Plate 4 – View looking south west within the Onshore CO<sub>2</sub> corridor showing marshy pond areas north east of the Main Teesworks Site.**

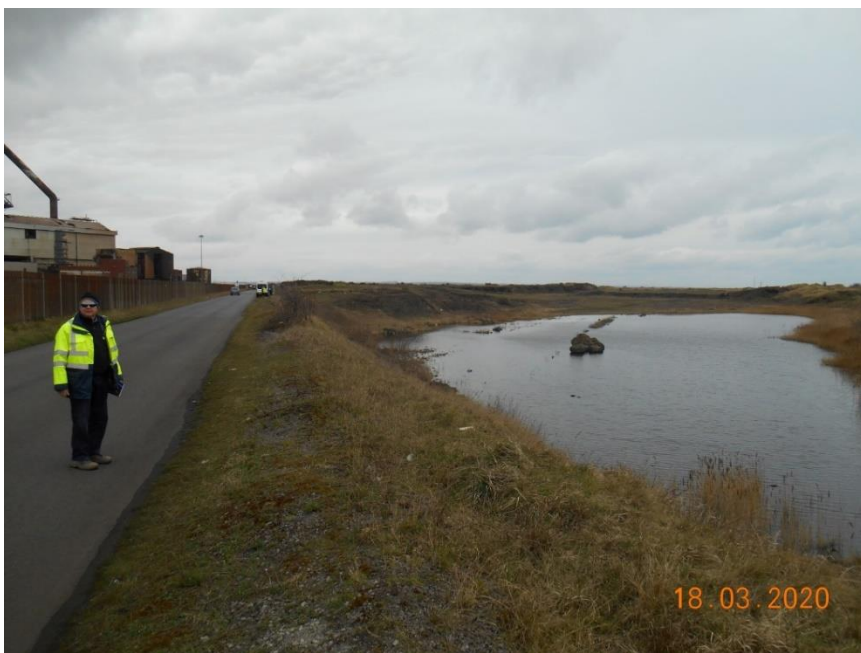
A larger and more permanent pond is present north of the unnamed road adjacent to the north west corner of the Main Teesworks Site. The bunded areas around the pond are formed of Made Ground primarily comprising waste slag materials from the former Redcar Iron and Steel Works, shown on Plate 5 below.

**Plate 5 – View looking north west along unnamed road and permanent pond.**

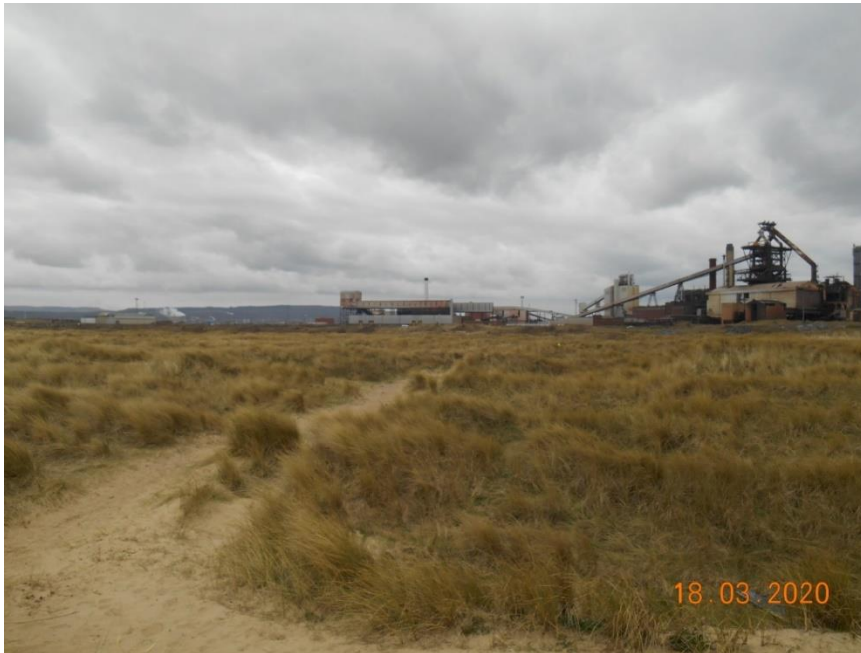
**Plate 6 – View looking south southwest showing the dune habitat in the area of the proposed CO<sub>2</sub> corridor showing the proposed Main Teesworks Site in the background.**

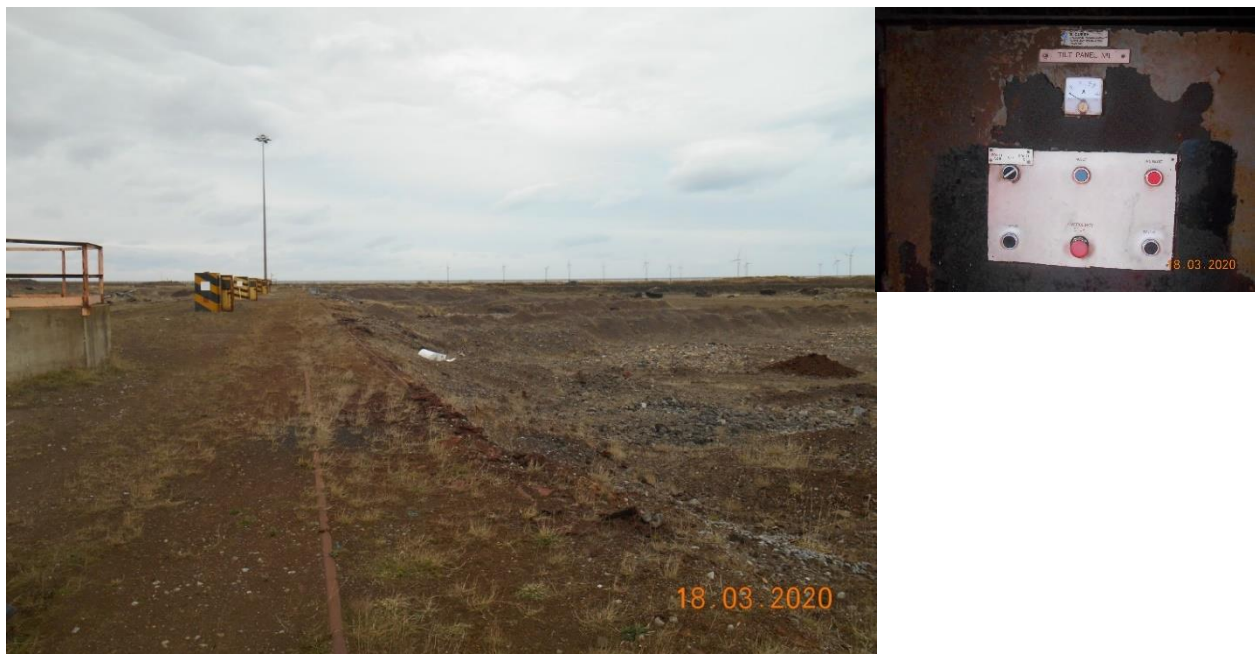
**Plate 7 – View looking north west along the alignment of the steel torpedo 'pond area'. The tilt operation booths are seen yellow/black on the left hand side of the photograph (see insert showing Tilt Panel to the right), with running rails for the tippers shown on the edge of the 'pond' areas.**

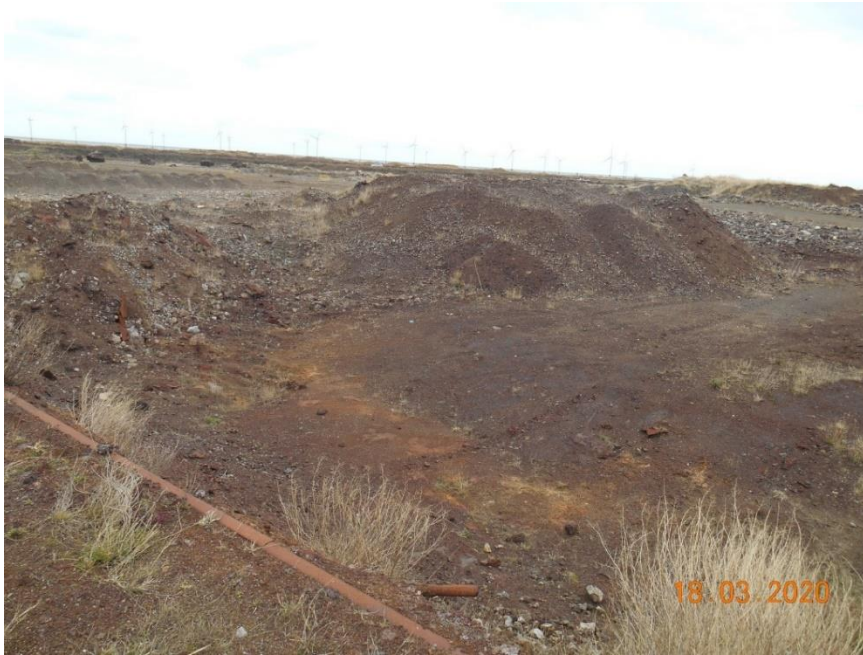
The former 'pond' area is now covered in various spoil heaps of blast furnace slag and crushed concrete, with metal detritus varying in size typical of gravel, cobbles and boulders across the area, see Plate 8. It was noted that there is no or little vegetation present across the former ponds. Land immediately south and south west of the 'ponds' was generally vegetated with grasses and included very large blocks of waste iron assumed to be associated with the practise of tipping of molten iron as described above, see Plate 9 for a typical 'block' observed.

**Plate 8 - View looking north showing typical spoil heaps of iron slag waste material.**

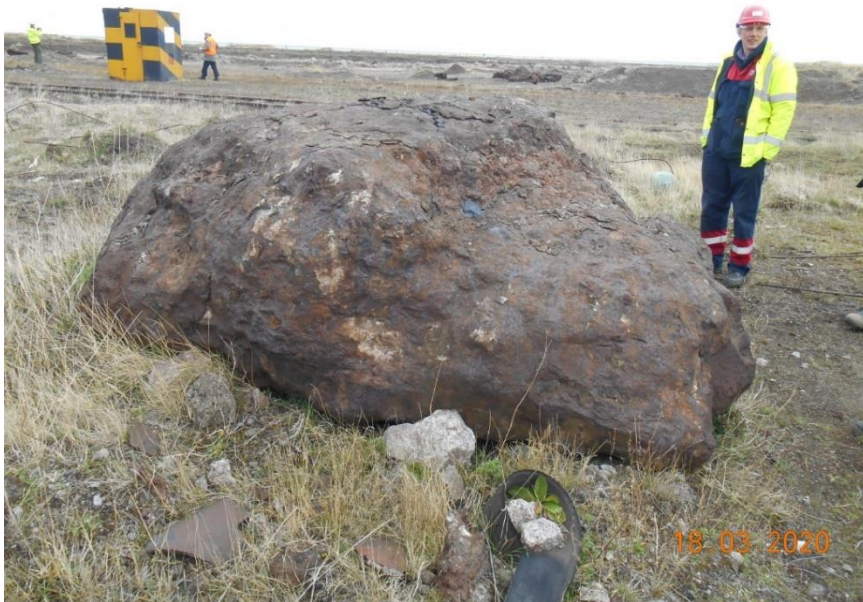
**Plate 9 - Typical example of waste iron blocks discarded across land south of the torpedo pond area. Estimated size 5.0 X 5.0 X 1.5m.**

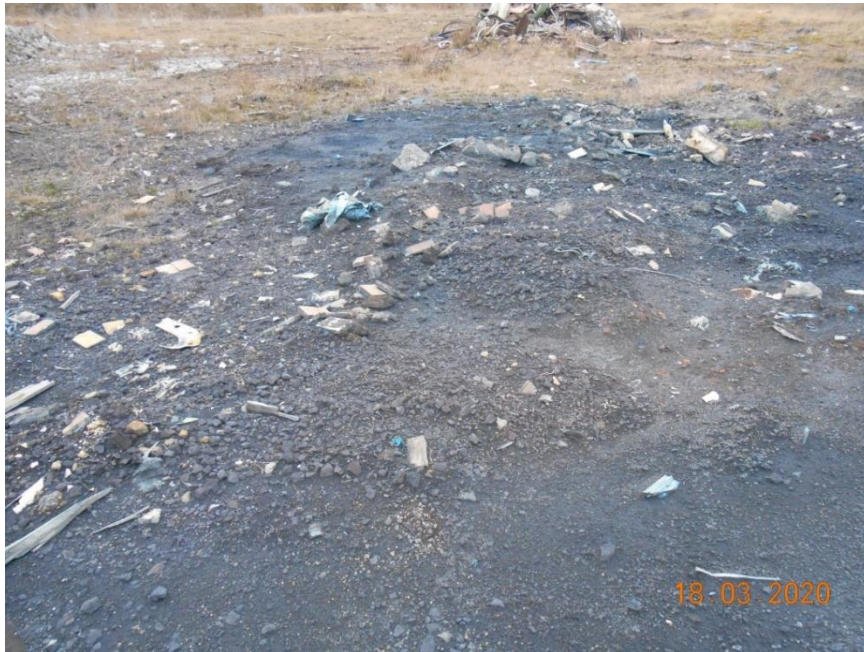
gasification (gas works) processors and also with coke works and manufacturing of coke for steelmaking. However, neither of these of these industries are recorded on historical OS mapping to have been present on the Site, with former Redcar Coke Ovens (RCO) and coke stocking area located some 200m to the west northwest. Therefore, the source of this contamination is unknown. However, groundwater monitoring data from previous ground investigations by others has identified cyanide contamination within groundwater in this area, so the source and extent of contamination should be determined by ground investigation.

**Plate 10 – Surface soils discoloured blue typical of cyanide contamination.**

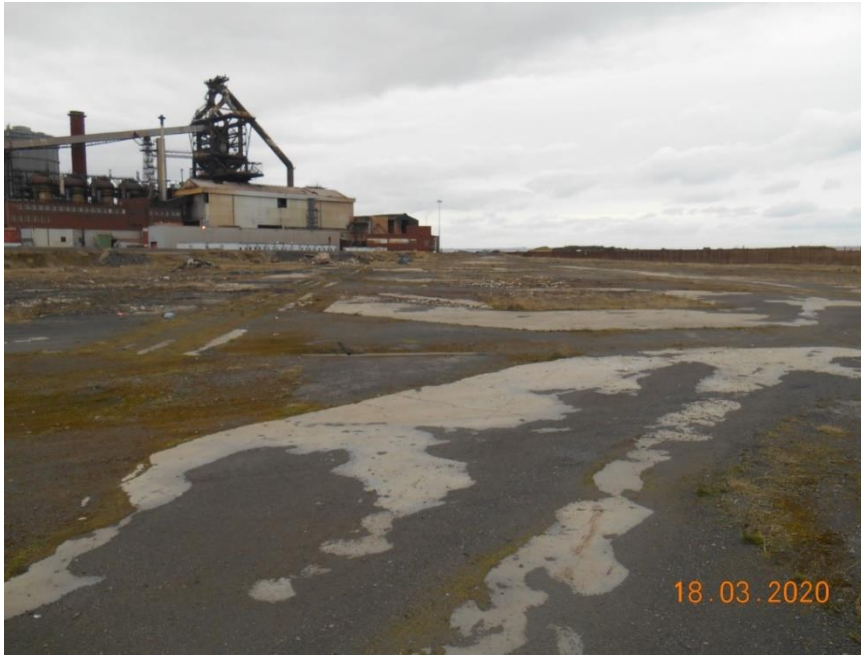
The second area of interest comprises hardstanding and remnants of four hexagonal areas of hardstanding understood to be foundation bases located in the north east corner of the proposed Main Teesworks Site, see Plate 11. These footings are thought to possibly be a result of the initial intention to build a further 2 blast furnaces (outside, and to the north west of the proposed site boundary shown on the left hand side of the photograph) which were subsequently never constructed. It is understood the initial production forecast for the existing plant was originally intended to be three times the actual production capacity, but was scaled down due to economic demand at that time. The circular foundations do not include concrete within the centre as it is understood this would have housed a low collection point required as part of the production process.

**Plate 11 - View looking west- north west showing remnant foundations and hardstanding.**

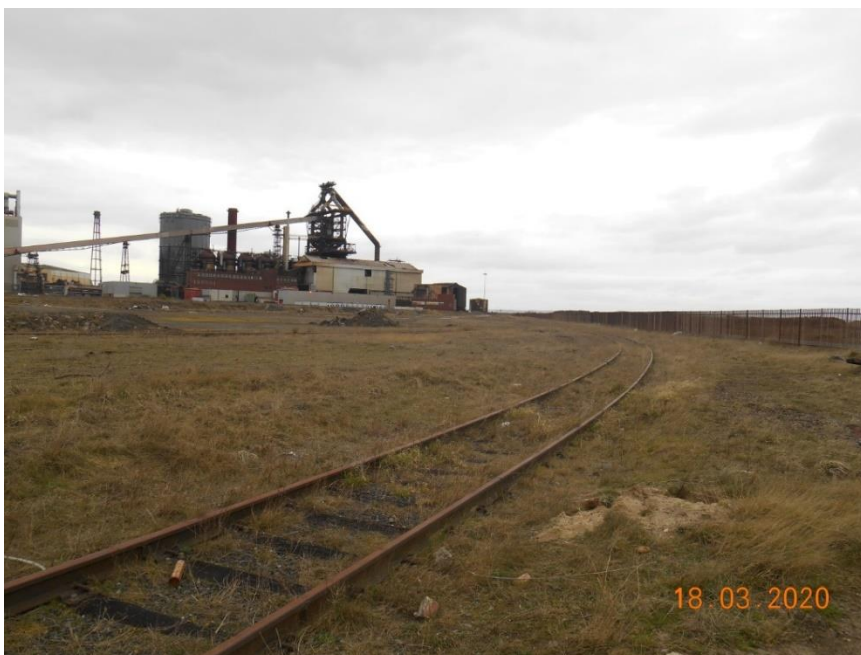
**Plate 12 - Rail siding running along the north boundary of the Teesworks Site.**

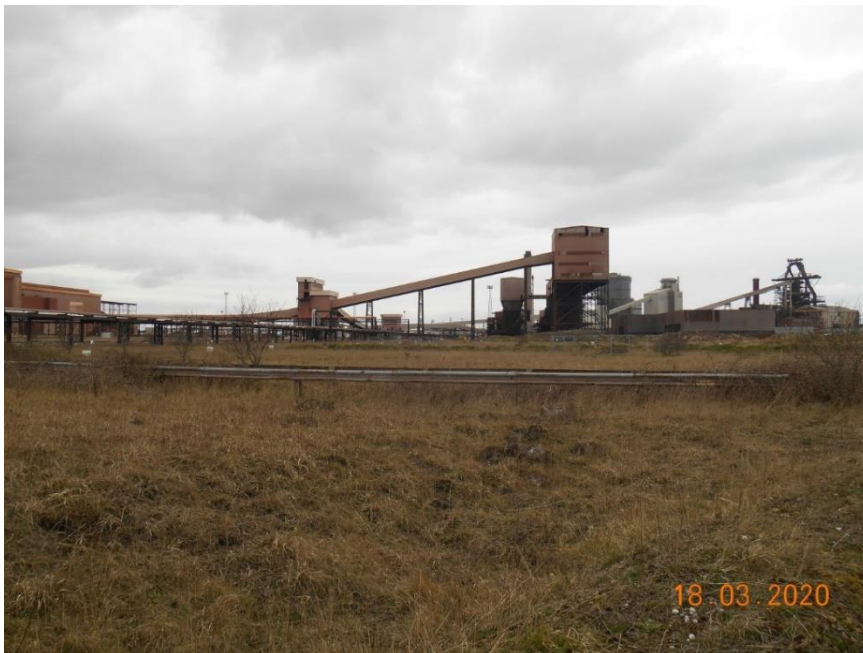
The area of open ground and the Blast Furnace Stockhouse is shown Plate 13. Access below or into any of the structures was not permitted during the walkover due to The CDM Regulations (2015) and Health and Safety restrictions. Safety barriers seen running across the foreground of the photograph delineate known service corridors, particularly for high voltage buried cables.

**Plate 13 – View looking west showing area of open ground, Blast Furnace Stockhouse and associated buildings. The Blast Furnace is shown on the right hand side of the photograph which is outside and north west of the proposed site boundary.**

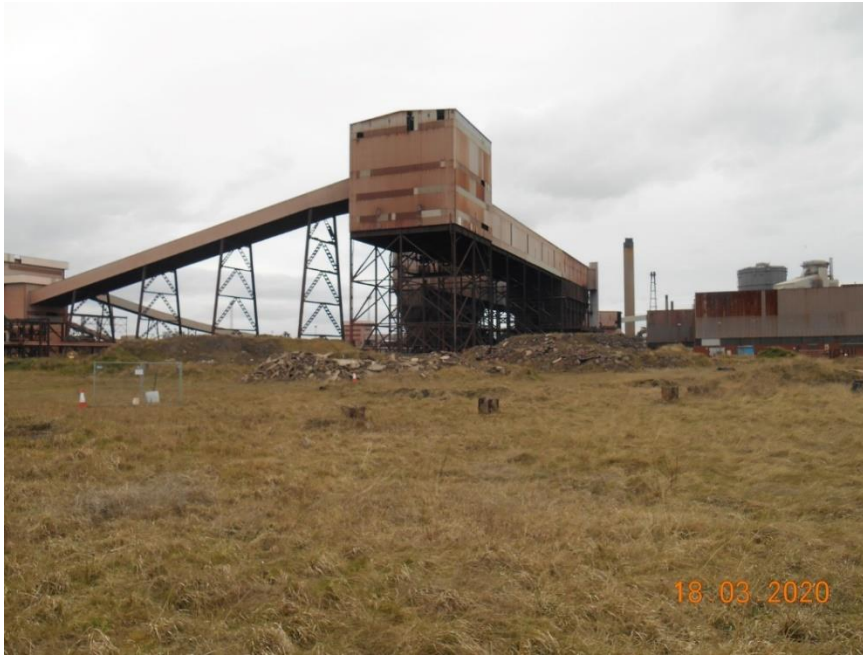
The area immediately east of the Blast Furnace Stockhouse is currently covered by large stockpiles of mixed materials and slag (left hand side) and broken concrete slabs and foundations (right hand side) which it is understood from the STSC representative to be associated with demolition of former structures associated with the SSI works, see Plate 14. This area is also reported to have previously been used as a site wide diesel (and possibly other/s) refuelling area. It is unknown if the tanks and associated infrastructure and pipework still remain buried on the site. A number of historical cut-down structure stanchions are visible in the foreground of the photograph. These run along the alignment of the former large structure associated with the former Redcar Iron and Steelworks Steel Plant building (~1929 to 1973), see Plates 14 and 15.

**Plate 14 – View looking west showing stockpiles, former refuelling area and historical cut-down structure stanchions.**

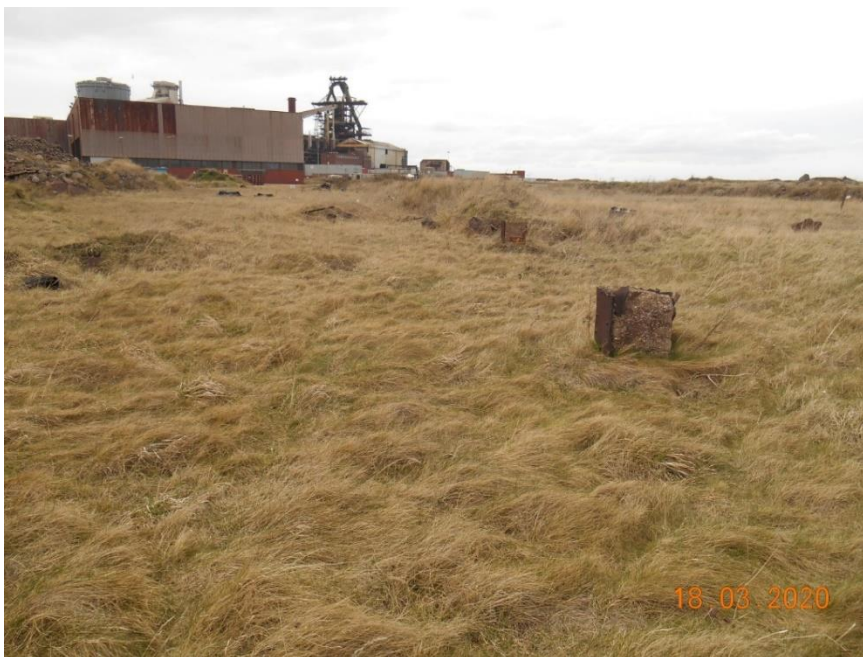
**Plate 15 – View looking north west showing cut-down structure stanchions along the alignment of the former Redcar Steel and Iron works Steel Plant building.**

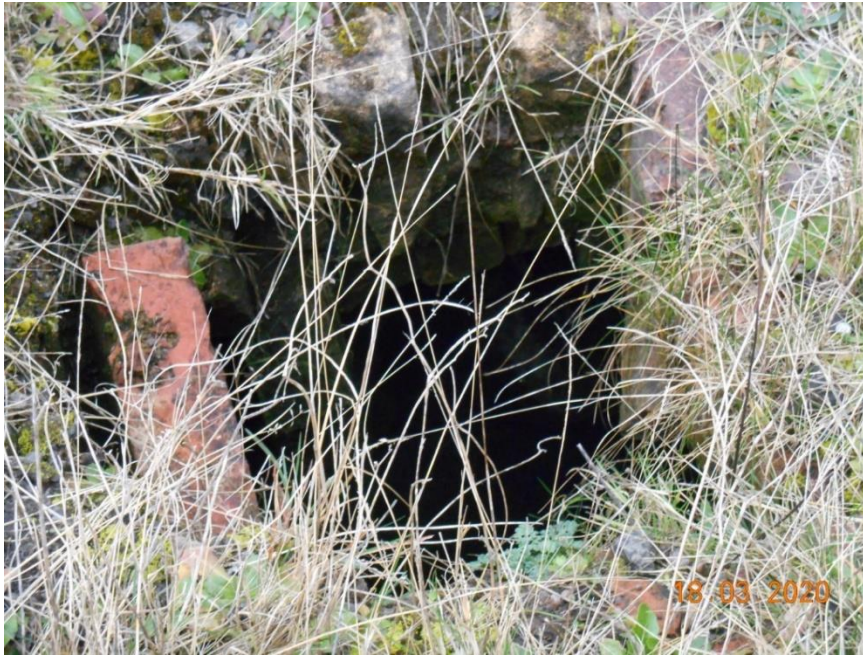
The area of open ground east of the Blast Furnace Stockhouse (see Plate 13) is known to be underlain by number of buried structures, caverns and brick lined tunnels, these within the area of Herras fencing shown in the centre of the photograph. These predate the existing SSI plant layout and are most likely associated with the earlier former Redcar Iron and Steelworks site (present on site from 1929 to 1973). The buried structures and tunnels may be associated with steel melting hearths and ventilation tunnels with anecdotal evidence suggesting there were ten steel melting hearths on the site, although these are not shown on any historical OS mapping. The

**Plate 16 - Surface expression of buried structures and tunnels.**

merits of undertaking geophysical investigations including Ground Penetrating Radar (GPR) and/or Resistivity techniques was discussed on site as a suitable for a Phase 1 investigation to aid determination of the location, direction and extent of these across this area. Access into the fenced areas was not permitted during the site walkover due to The CDM Regulations ( 2015) and Health and Safety restrictions, however there is little visible surface expression of these features as shown in Plate 16.

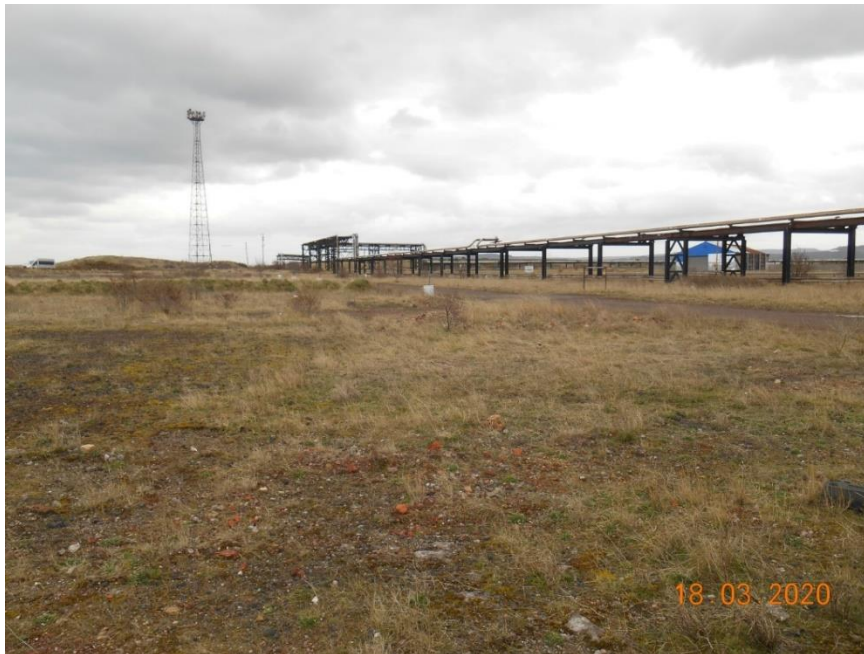
The south part of the central area is delineated by an overhead network of pipelines and a further internal access road. From discussion on site the overhead network carries a number of different materials for the industrial processes undertaken and include but not limited to fuel oils and the Cog Oven Gas (COG) main that is piped to South Bank from the coke ovens west and outside of the Site boundary, see Plate 17.

**Plate 17 – View looking east south-east showing overhead COG and fuel oil pipelines. The RDL Stores building and associated canteen are located in the north east corner of the central area adjacent to the east boundary of the Site boundary, see Plate 18. It is reported that historically there may have been some storage tanks (contents unknown) west of the structures associated with stores.**

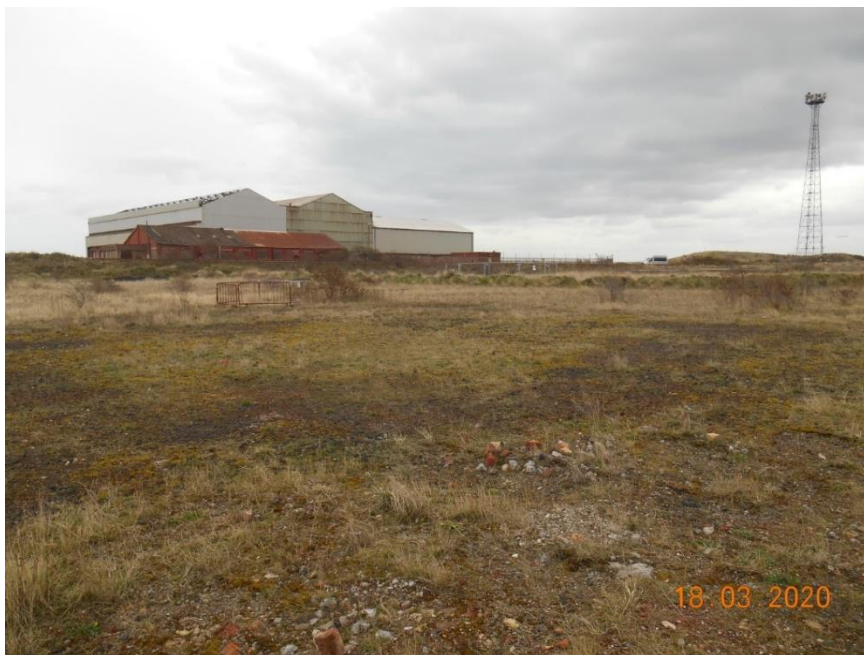
**Plate 18 – View looking north east showing RDL Stores and Canteen. A lighting column is visible on the right hand side of the photograph, with others**

present elsewhere across the site. In some areas the columns have been removed and foundations are present at ground surface.

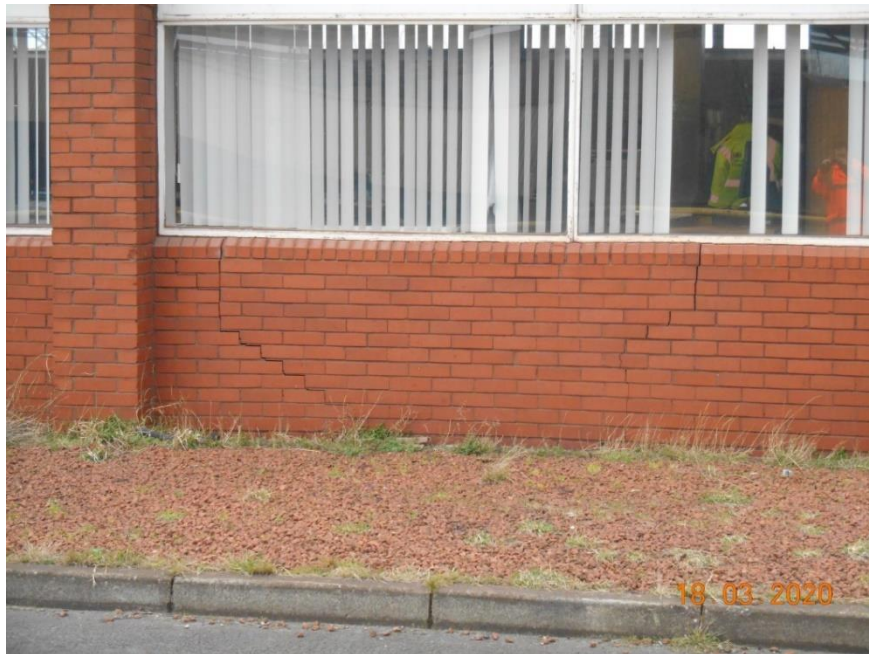
The structures in this area are of brick construction. Waste slag material is present widely across the whole site, with evidence of the expansive nature of this material visible through structure deformation and cracking in the walls of these buildings. Plate 19 shows the STSC offices and Plate 20 shows the Pellet Tunnel building.

**Plate 19 – View looking north showing structure deformation and cracking on the STSC office building.**

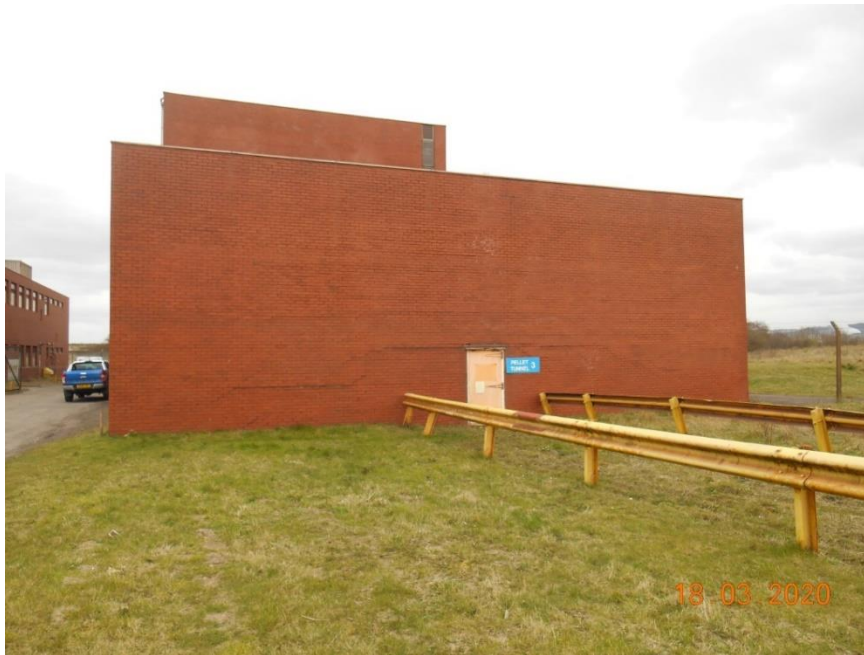
**Plate 20 – View looking west showing deformation across the Pellet Tunnel building. It is noted that the extent and direction of the tunnels are not known at the time of this report issue, however STSC have indicated that these records should be available for release. The barriers leading to the structure again delineate the corridor of buried underground services and high voltage cables.**

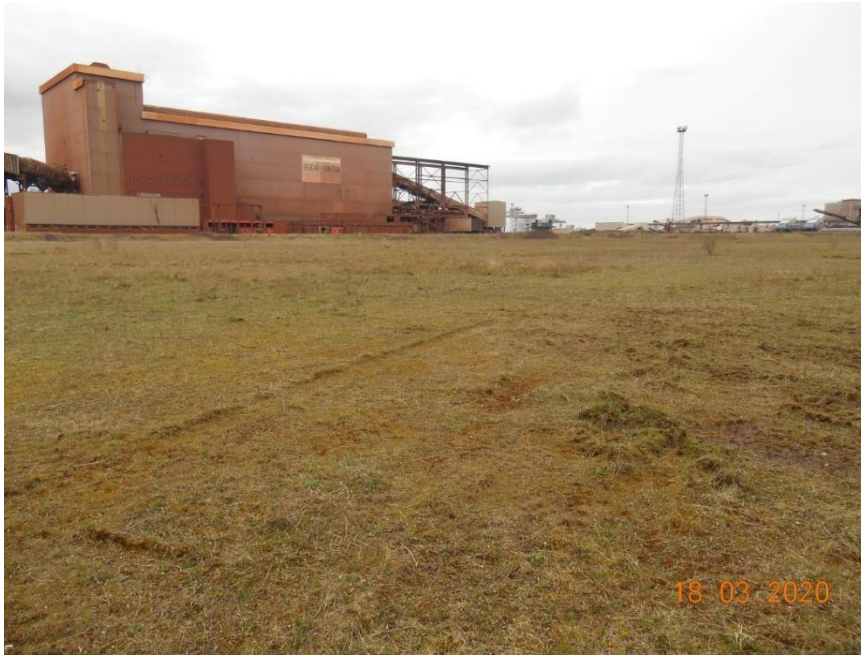
**Plate 21 - View looking south west showing the Sinter Plant adjacent to the south boundary of the proposed site.**

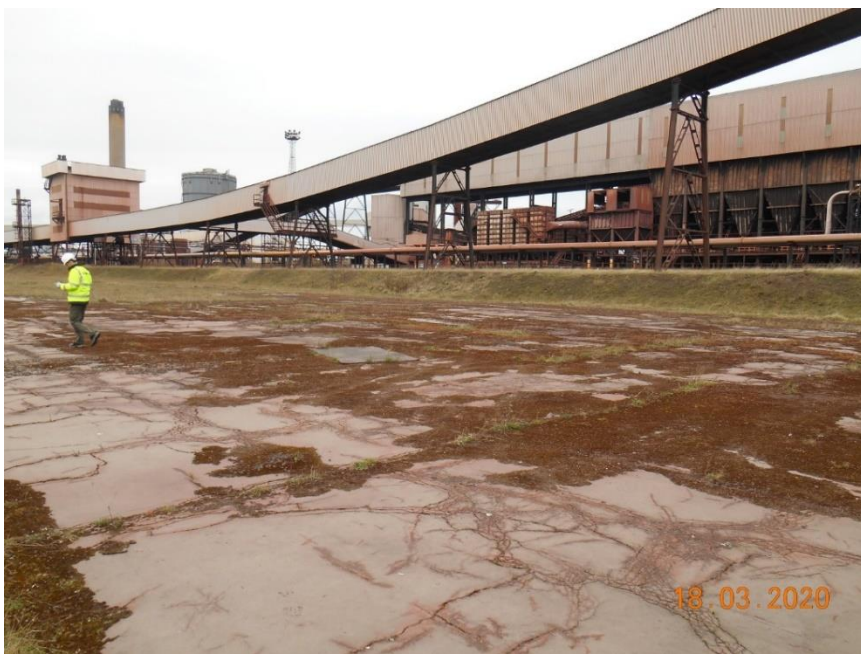
The north portion of this part of the Site is bounded by the Blast Furnace Stockhouse. An area of remnant hardstanding is present across this area, see Plate 22. It is understood that it was originally intended to construct three sinter plants across this area, however due to economic conditions and demand only one of these was constructed, with this relict hardstanding possibly associated with this.

**Plate 22 – View looking north west showing area of remnant hardstanding and the Blast Furnace Stockhouse.**

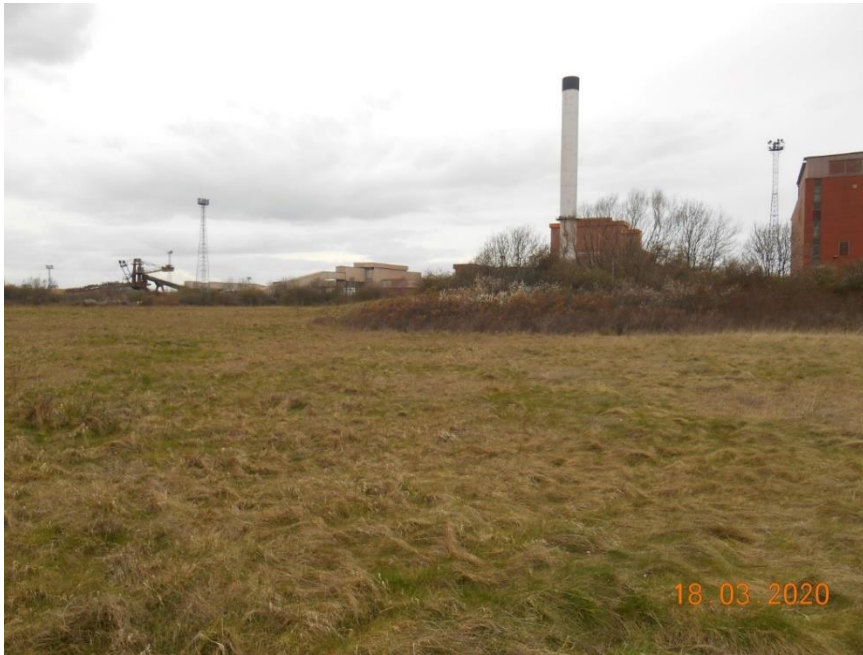
Land to the east of the STSC offices generally comprise areas of grassland and an area of remnant hardstanding. The south east corner of this part of the Site was historically occupied by a Pellet Plant demolished in the 1980s, see Plate 23.

**Plate 23 – View looking south west. The Pellet Plant was located across the grassland shown on the left hand side of the photograph. There is no visible surface evidence of the former structure. The chimney stack shown in the background is associated with the Sinter Plant and is located adjacent to, but outside of, the Teesworks southern site boundary.**

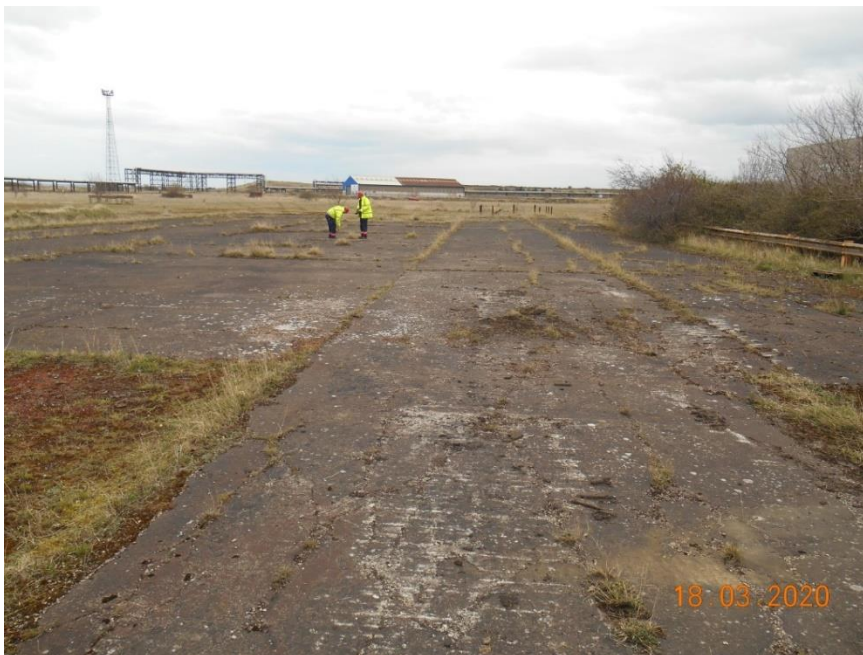
**Plate 24 – View looking east southeast showing a hardstanding area. It was noted that the hardstanding surface is ‘wavy’ and cracked, again providing**

**evidence of heave inferred to have resulted from the presence of expansive slag materials below this area.**

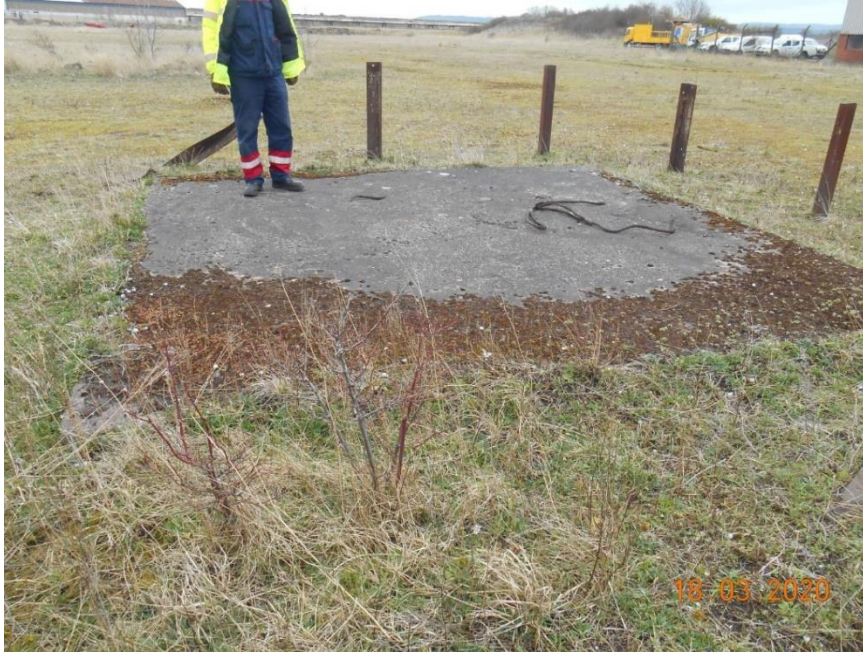
Further localised foundation bases were visible across this area, thought to be associated with former lighting columns, see Plate 25.

**Plate 25 - View looking east southeast showing foundation base.**

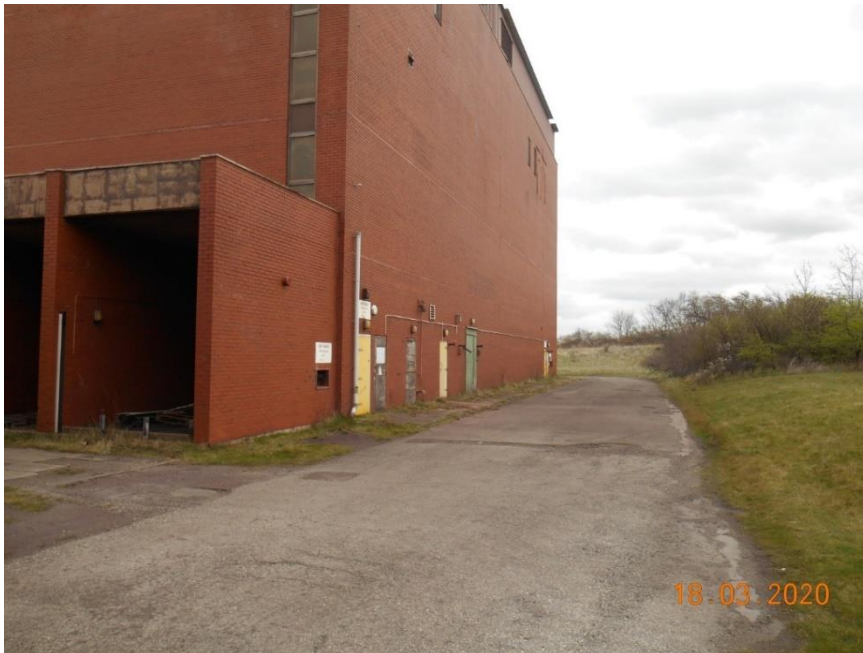
**Plate 26 – View looking east southeast showing a brick construction maintenance building.**

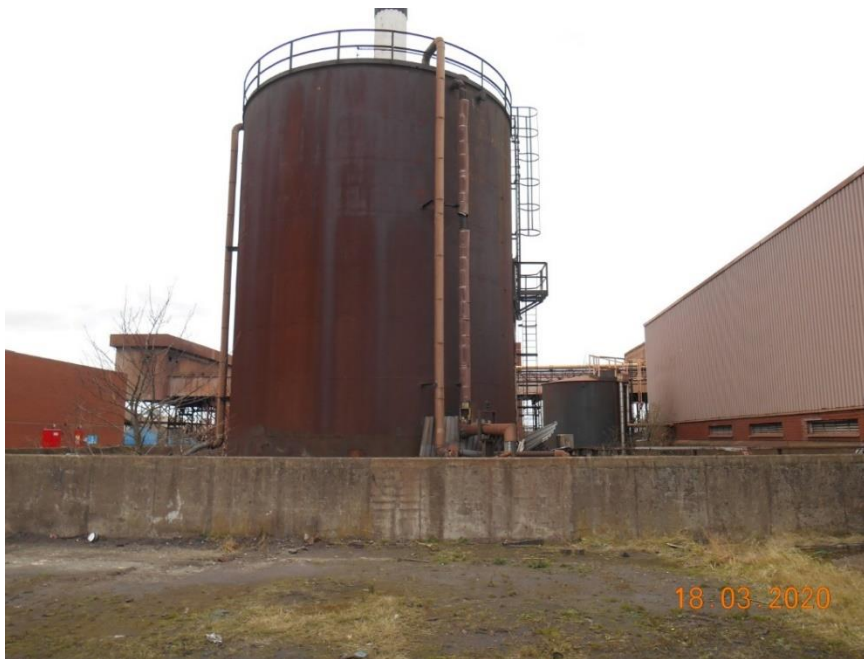
A large storage tank reported to have a capacity for 200 tonnes diesel is located between the former Pellet Plant and the Sinter Buildings, see Plate 27. This is

located adjacent to, but outside of the proposed south boundary of the Teesworks Site. The tank is located within a concrete bund which appeared to be of sound construction. The site representative from STSC confirmed that the tank was removed from service prior to SSI purchase of the site but was not fully emptied. It was noted that pipe cladding insulation materials were fibrous in nature and may represent an asbestos risk, see Plate 28. This would need to be established through testing although it is noted that the tanks will most likely be demolished as part of the STSC site clearance works.

**Plate 27 – View looking west northwest showing diesel tank and surrounding concrete bund wall.**

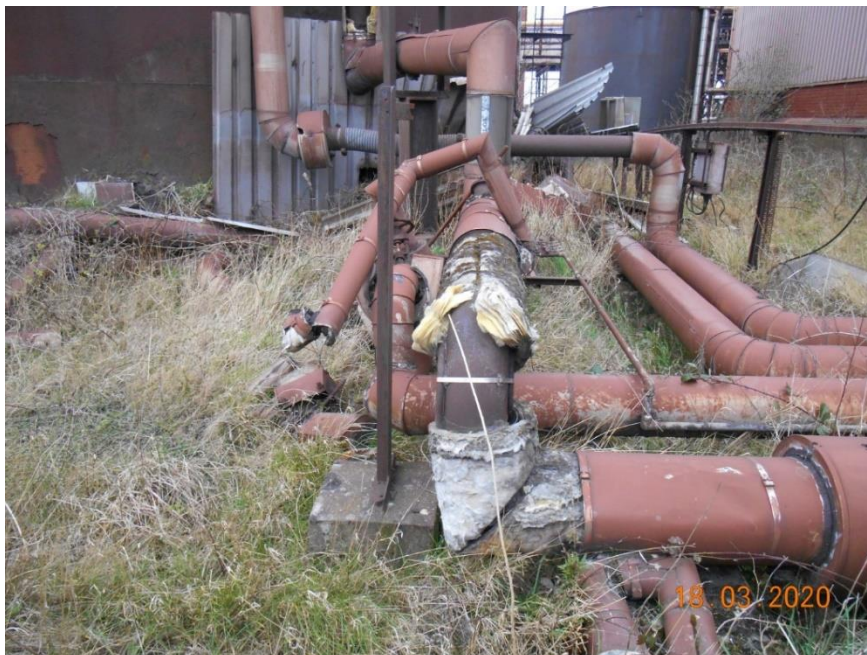
**Plate 28 – Diesel tank connections and fibrous pipe lagging.**
